Manhole Inspection Summary

Manhole # S23E1_002MH

Location Address: **Hollins Ferry Rd.**

Cross Street: **Waterview Av.**

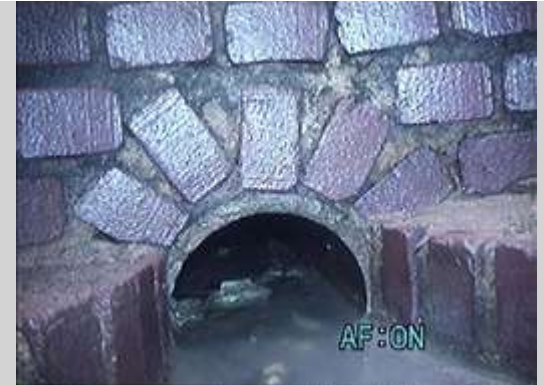
12 O'Clock Outflow

8 in. Circular Gravity Sewer
Pipe Out @ 12 O'Clock

Pipe Height: **8.4** (in.) Rod and Bar (Angled)
Pipe Material: **Clay** ☐ Pipe Lined
Invert Depth: **10.49** (ft.) Flow Characteristics: **None**
Deposits: ☒ None ☐ Mud ☐ Sludge ☐ Debris ☐ Grease
Silt Depth: **0** (in.) Deposits Extent:
Infiltration: **None** Pipe Seal Cond: **Sound**

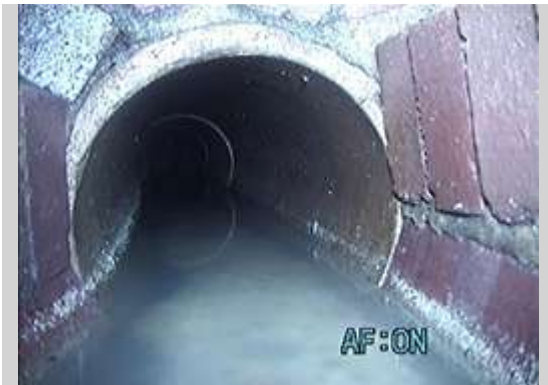
4 O'Clock Inflow

8 in. Circular Gravity Sewer
Pipe In @ 4 O'Clock

Pipe Height: **8.4** (in.) Rod and Bar (Angled)
Pipe Material: **Clay** ☐ Pipe Lined
Invert Depth: **10.48** (ft.) Flow Characteristics: **None**
Deposits: ☒ None ☐ Mud ☐ Sludge ☐ Debris ☐ Grease
Silt Depth: **0** (in.) Deposits Extent:
Infiltration: **None** Pipe Seal Cond: **Sound**

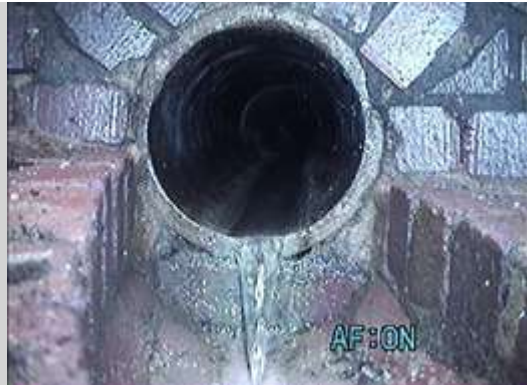
8 O'Clock Inflow

8 in. Circular Gravity Sewer

Pipe In @ 8 O'Clock

Pipe Height: **8.4** (in.) Rod and Bar (Angled)

Pipe Material: **Clay** ☐ Pipe Lined

Infiltration: **None** Pipe Seal Cond: **Sound**
